MANPRINT ASSESSMENT OF THE
HIGH MOBILITY MULTIPURPOSE WHEELED VEHICLE
HEAVY VARIANT (HMMWV-HV)
(Contract MDA903-83-C-0033)

Daniel A. Krohn Douglas K. Spiegel Essex Corporation

March 1988

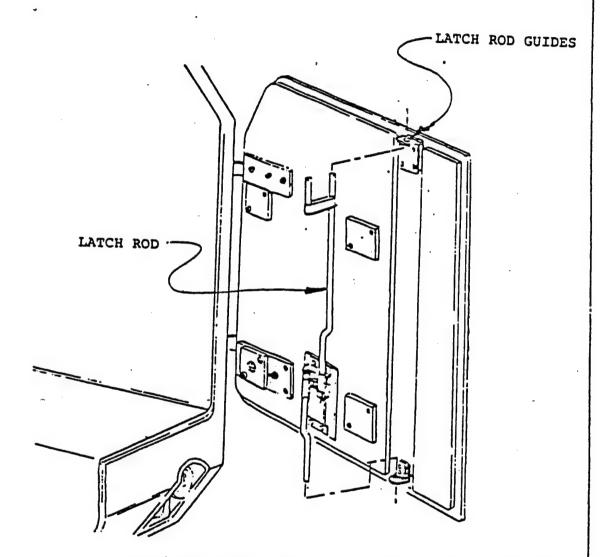
- b. During cross-country operations, a rocking motion set up by road conditions results in locked doors shimmying back and forth relative to each other. This swaying works the latch rods until the door handle twists and the door opens.

- d. Latch rod seats have sustained a great amount of wear, reducing their ability to properly seat the latch rod.

Unsecured doors pose a safety hazard to personnel inside the enclosure. May require unscheduled stopping for the ambulance.

LATCH ROD SEATS (NOT SHOWN) MOUNTED TO THE CEILING AND THE RETRACTABLE STEPS

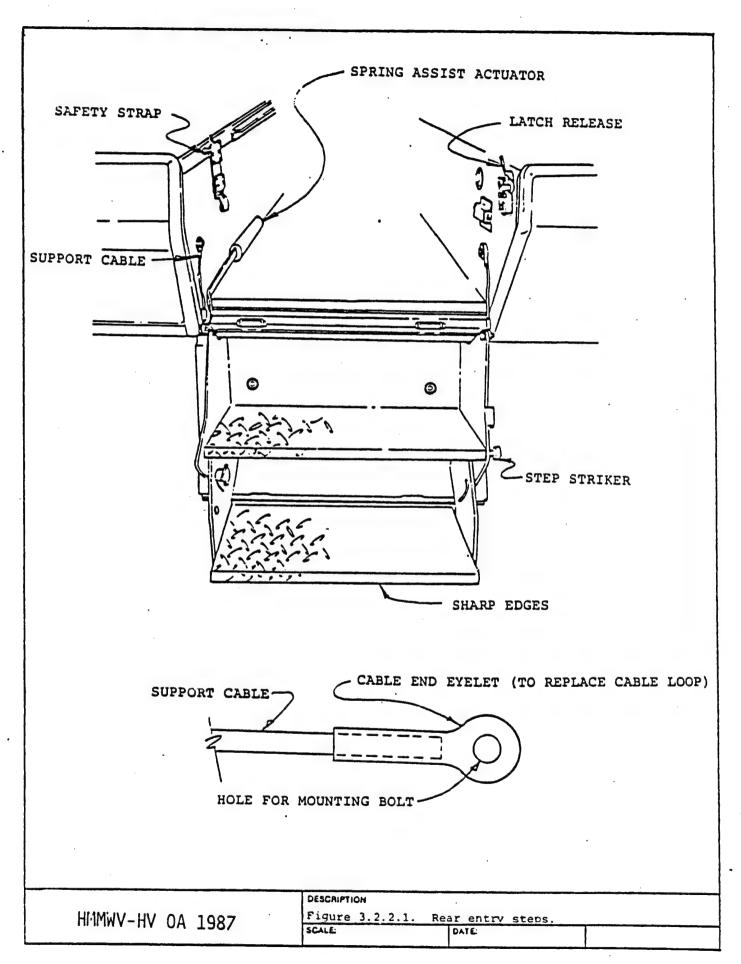
- a. The stair release latch is stiff, prone to sticking, and interferes with the litter support strap in the maxi-ambulance (see Figure 3.2.2.1).
- b. The safety strap for stowed position is hidden from operator's view while the operator is attaching or unattaching the strap hook.
 - c. Sharp edges on steps have caused lacerations of the operators hands.
- d. The stair support cables have come off of their attachment fasteners (see Figure 3.2.2.2).
- e. The mini-ambulance step seat (used while steps are in stowed position inside the van) restricts the headroom of a seated aidman.

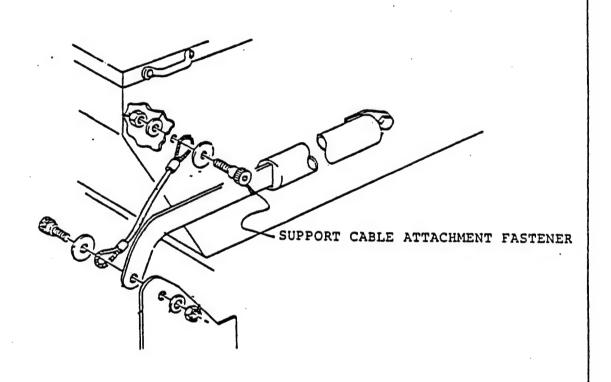
DESCRIPTION
Figure 3.2.2.2. Support cable.

The step latch hardware, when fouled with dust, malfunctions. The motion to actuate the release lever is lateral to operator's frontal plane and is difficult to grasp in order to release. The stair support cable loops wear, increasing their diameter and allowing them to come off their mounting fasteners (see Figure 3.2.2.2).

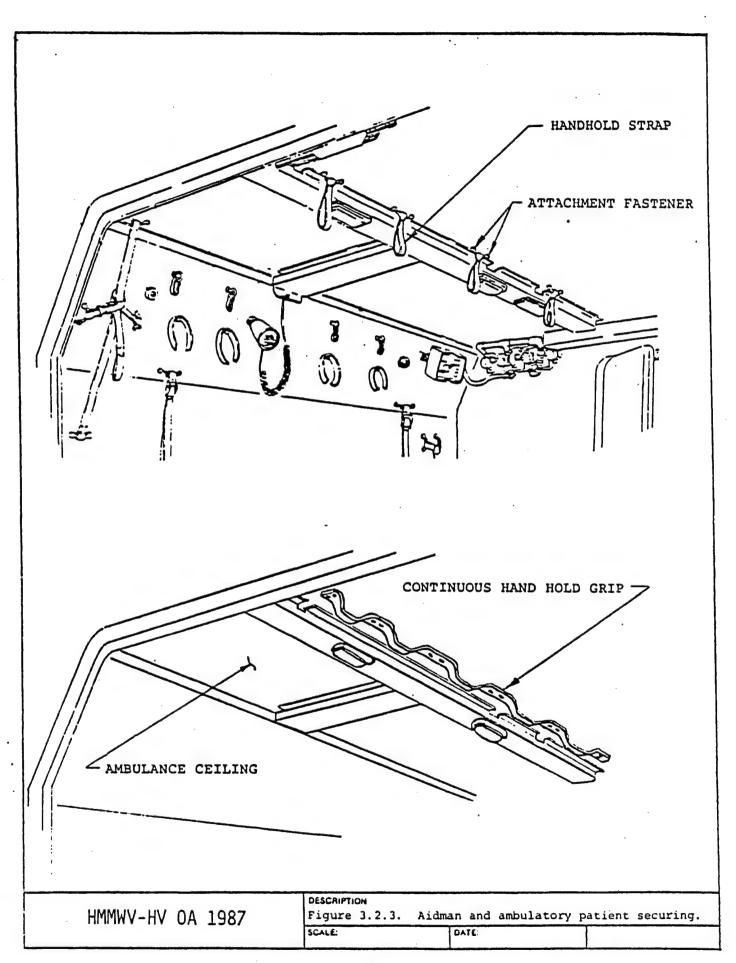
- c. The mini-ambulance has handhold straps for use by seated ambulatory patients. The securing fasteners frequently failed, rendering the strap useless. It is also difficult to slide hands in and out of the hand strap loop (see Figure 3.2.3).

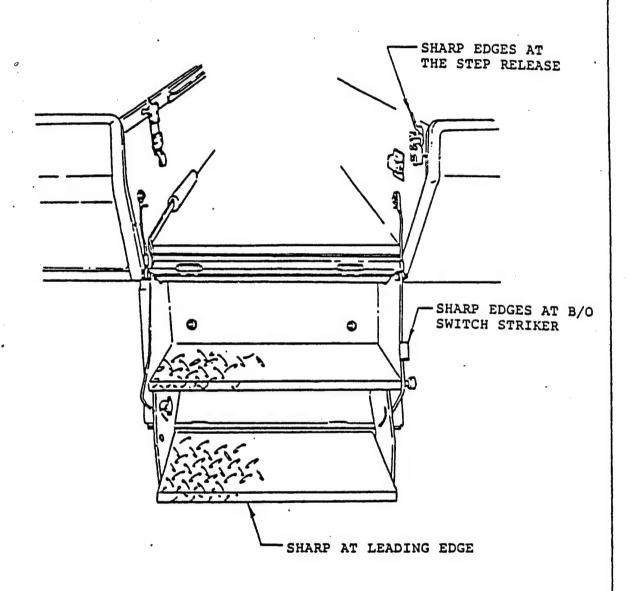
REAR STEP OF MAXI- AND MINI-AMBULANCES

- 1) Edges of aspirator/resuscitator stowage tray.
- 2) Edges of upper litter rack metal structure.
- 3) Inside edges of partially rolled edge of stowage area/litter area partition.
- 4) End of light bar structure next to air conditioning outlets.

Manufacturing processes that leave an unfinished edge and corners of equipment where projections are not padded or broken.

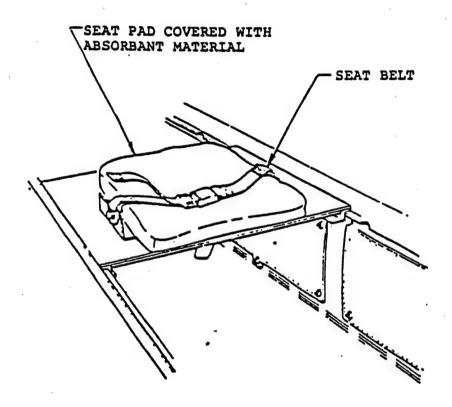
DESCRIPTION
Figure 3.2.5. Aidman's sliding seat.

Attendants commonly straddle the attendant's seat but must lean awkwardly to access the patient's head, thus decreasing attendant's effectiveness and comfort. Lack of back support for the attendant's seat allows the attendant, with or without the seat belt, to slide and fall backwards out of the seat when the vehicle travels on rough roads or during hard forward vehicle accelerations. An absorbent seat covering will allow contaminants to penetrate and remain lodged in the seat. This condition will make cleaning of biological materials or other contaminants, without replacing the cushion, extremely difficult. The aidman must leave the attendant seat to access upper litter patients. This can result in injuries to aidmen from being thrown about the ambulance compartment.

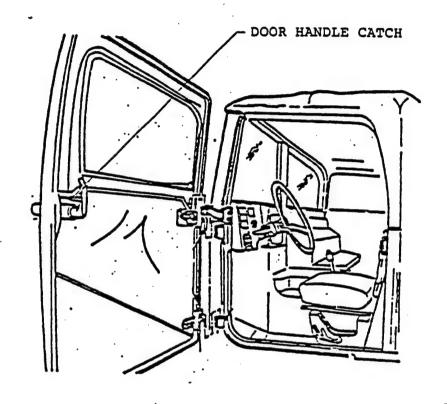
The soft top system for the HMMWV S-250 shelter carrier has deficiencies including:

- a. The rear curtain is loose and flaps excessively leading to high noise levels in the cab.
- b. The curtain does not seal tight behind the crewmen and at the door frames allowing dust and water to enter.
- c. Door latch handles are prone to unlatching and are shown in Figure 3.2.6.
- d. Side visibility is distorted due to reduced transparency of the side plastic windows. The plastic windows also prevent optimal use of the side mirrors (when the windows are in the up position).

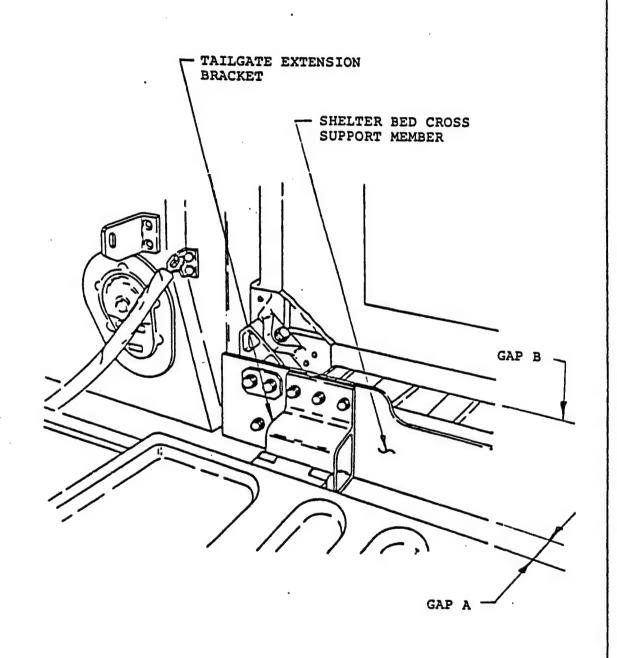
Figure 3.2.7. Shelter carrier tailgate tripping hazards.

A tripping hazard exists for HMMWV-HV shelter carrier crewmen while entering or exiting the communications (S-250) shelter. There are two hazard locations shown in Figure 3.2.7:

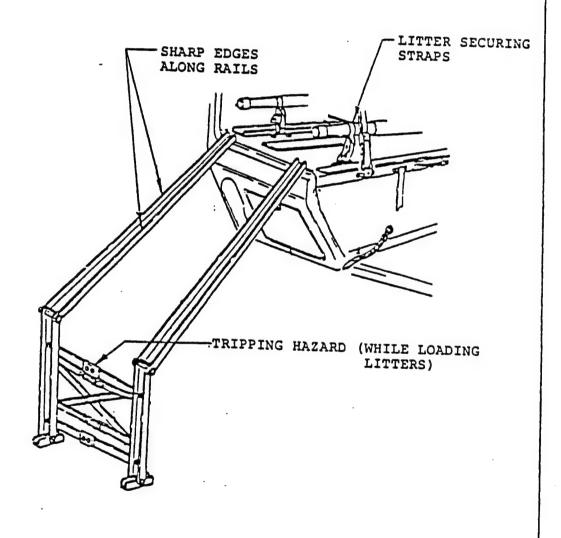
Pigure 3.3.2. Litter loading and unloading ramp.

- 2) The securing strap hooks slide down the tapered litter handles and come loose.
- c. To secure the upper litter while loading, the aidman must reach over the litter bearer who is holding up the tilted litter. This is further complicated by the difficulty in achieving proper tension with the securing straps.

- a. Sharp edges cut the aidman's hands while lifting the litters away from the ramp rails and while litters are slid up the ramp. Aidmen may lose control of the litter due to either the ramp disconnecting from the vehicle or their tripping over the structure at the ramp base. Litter loading is delayed due to the interference caused by the litter catching on the litter restraint straps.
- b. A litter strap malfunction may result in an unsecured litter. Setting the litter strap tension is slow. Operators must first guess at the proper adjustment for the strap and then clamp the device. If the tension is guessed wrong, the procedure must be repeated.
- c. Difficulty securing upper litter patients while loading in the maxiambulance slows the patient loading process.

- a. Litter ramp rail edges should be rolled. The litter ramp attachment to vehicle lugs should be altered to increase their ability to stay secured. Loading procedures should be revised to have litter bearers load litters using a side-carry loading method. This method would avoid the litter ramp structure tripping hazard and would also allow for both litter bearers to apply the lifting and pushing forces required to load the litter.
- b. Incorporate a litter-securing device that first clamps to the litter. Second, litter securing tension is applied.
- c. Improvement of the litter-securing straps would effectively reduce problem la.

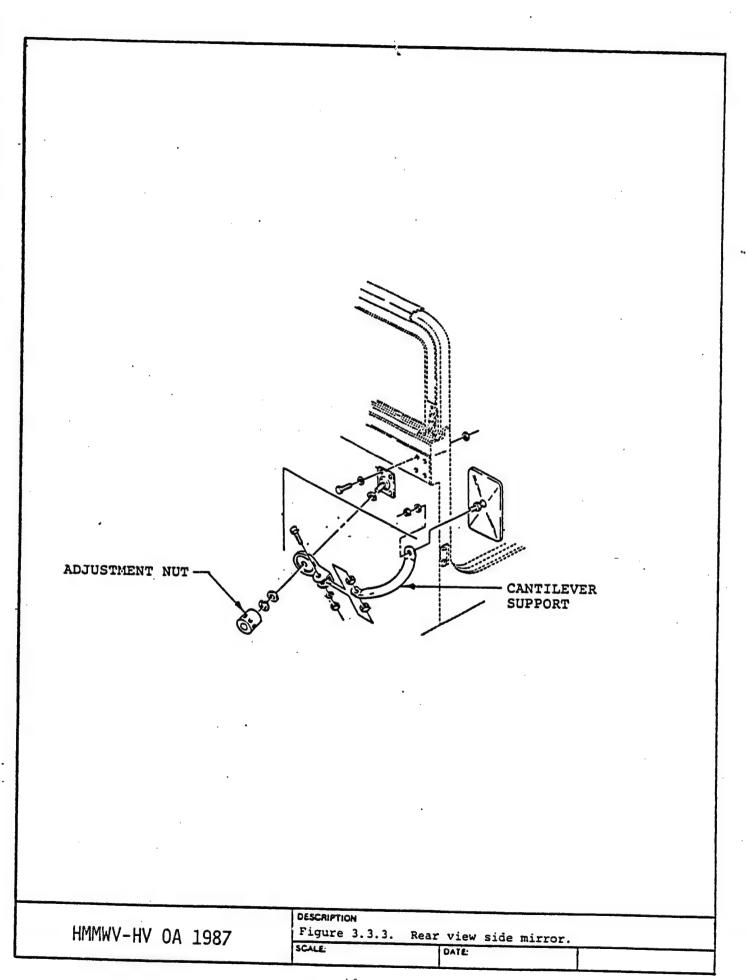
The side mirrors on the HMMWV ambulances and shelter carrier are too small and vibrate excessively. The hardware for mirror adjustment to the window frame mount vibrates loose, and the mirror falls to the side of the vehicle due to the length of the support. Operators claim the passenger side mirror is poorly positioned and does not provide a view. Shelter carrier drivers complain they do not have adequate rearward view to monitor their trailer status.

The mirror is supported by a single support that is approximately 20 inches (50 cm) long and is cantilevered from the mounting and adjusting hardware (see Figure 3.3.3). Vibration acting on the same plane as the adjustment nut tends to loosen the nut.

Excessive vibration blurs operator's rearward view. Loose hardware disables the use of the mirror. The small size of mirrors, approximately 5 by 7 inches (12.5 by 17.5 cm), limits effectiveness.

- a. Increase support of the mirror by adding an extra support member in a triangular configuration.
- b. Increase size of mirrors. (Crewmen would prefer mirrors similar to those found on M35, 2.5-ton vehicles.

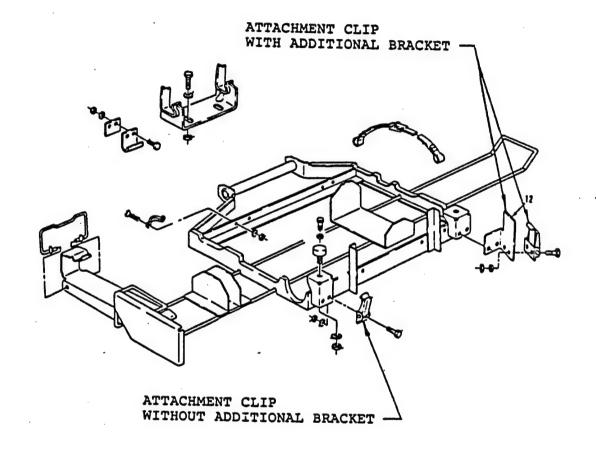
DESCRIPTION
Figure 3.3.6. Pioneer tool rack attachment.
SCALE: DATE:

Falls/injuries and/or vehicle damage likely.

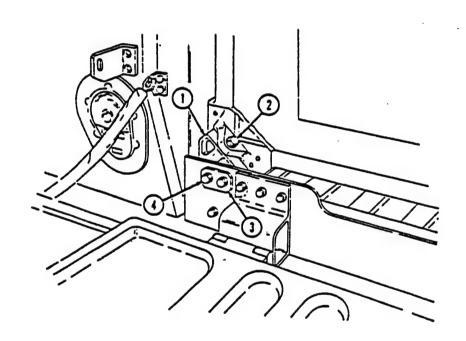
DESCRIPTION Figure 3.4.1.

- a. The mounting kit provided to adapt the S-250 shelter to the HMMWV-HV is not usable for all versions of the S-250 shelter.
- b. The mounting kit bolts (Figure 3.4.1, Items 2 and 4) behind the cab and passenger seat are difficult to align and start.

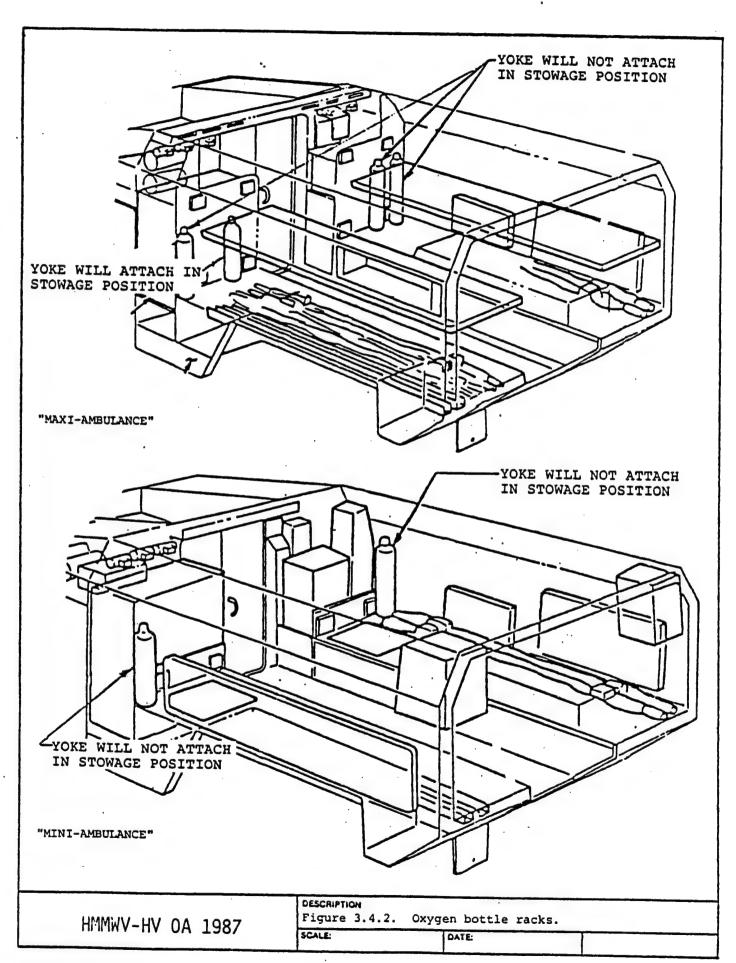
Oxygen bottles are not usable unless they are removed from rack and cannot be stowed until after yokes are removed. Bottles that are not secured during use or layed on the patient's litter may be thrown about a moving vehicle and cause injury to aidmen or patients.

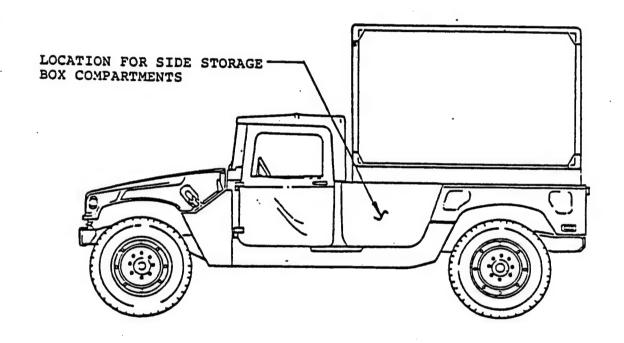
DESCRIPTION
Figure 3.4.3. Shelter carrier stowage.
SCALE:

Equipment that is stowed in the shelter is not restrained and moves freely about the floor of the shelter while negotiating terrain. This movement results in damage to the equipment and a stepping/tripping hazard to anyone entering the shelter. Time and effort are also wasted by crewmen removing heavy equipment from the shelter.
